NBS TECHNICAL NOTE 909

Investigation of Wind Damage in the Metropolitan Washington, D.C. Area, April 3-4, 1975

F. Y. Yokel, C. W. Yancey,
L. E. Cattaneo, and R. D. Marshall

A limited investigation was conducted of wind damage that occurred on April 3 and 4, 1975 in the Metropolitan Washington, D.C. area.

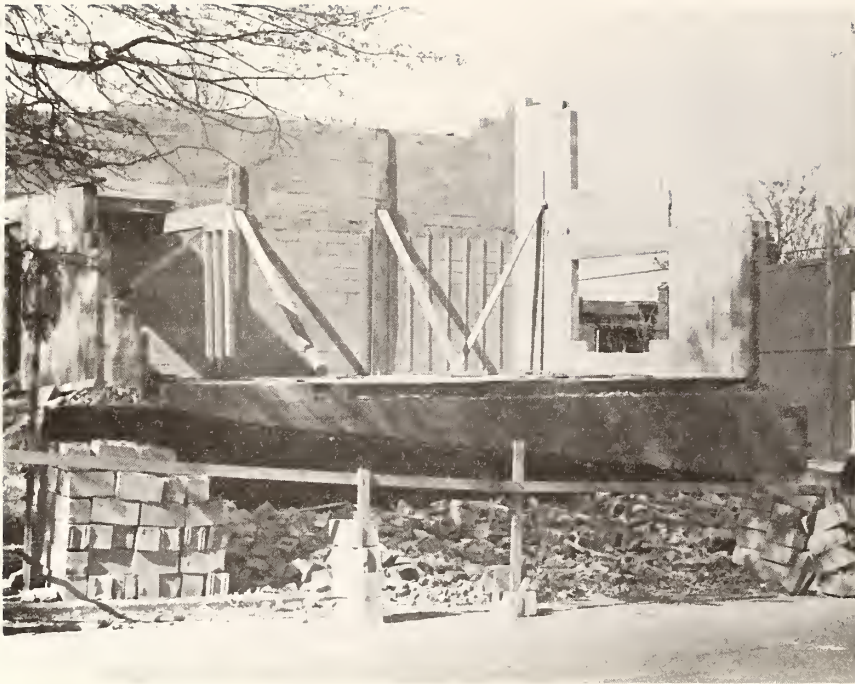
Figure 46 shows the end unit of a four-unit concrete masonry row house under construction. The exterior side wall of this unit collapsed and fell into the street causing two fatalities. (See the debris in the foreground of the photograph). Figures 47 and 48 are other views of the same structure taken from another street at right angles to the one into which the wall collapsed. The direction of the prevailing wind is shown by the arrow in figure 47. Note the partial collapse (figure 48) of cross-walls in other portions of the structure which were parallel to the exterior wall that collapsed. Details of the pulled-out joint reinforcement in one of the damaged cross-walls is shown in figure 49. The construction was 8 in (20 cm) unreinforced hollow concrete block with joint reinforcement. The incident illustrates the vulnerability of masonry walls in the construction stage before they are fully braced at their tops.

Figure 46 - End living unit of a four-unit masonry row house complex damaged during construction.

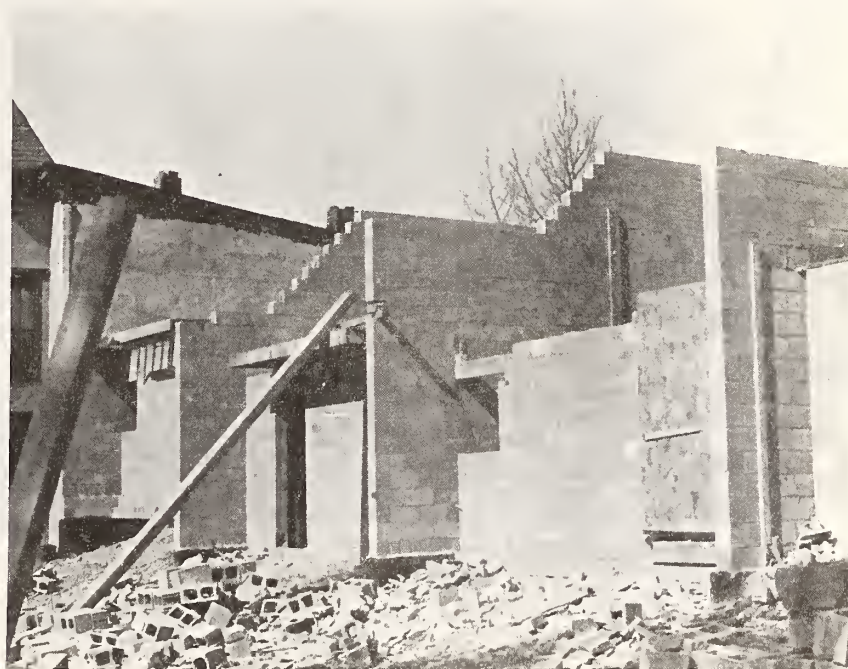
Figure 48 - Closeup front elevation of damaged masonry structures.

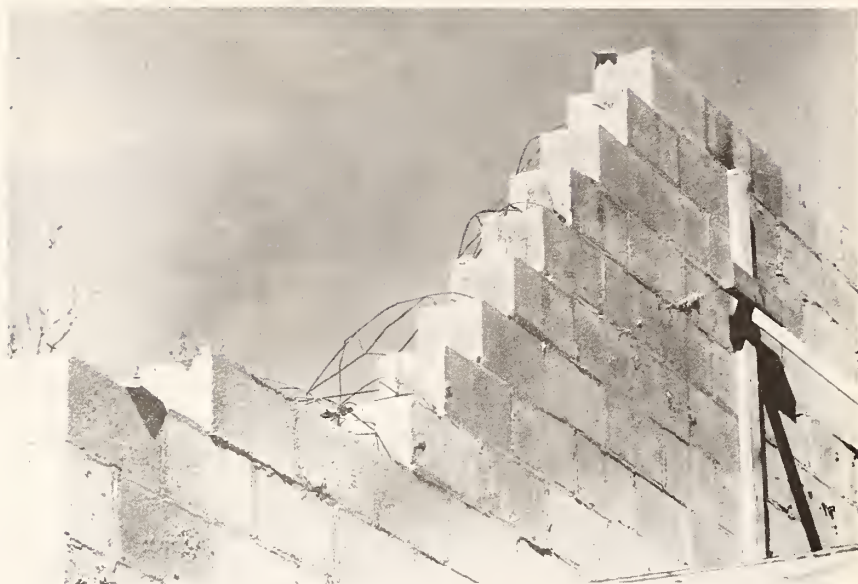
Figure 49 - Details of pulled-out joint reinforcement in a damaged cross wall.

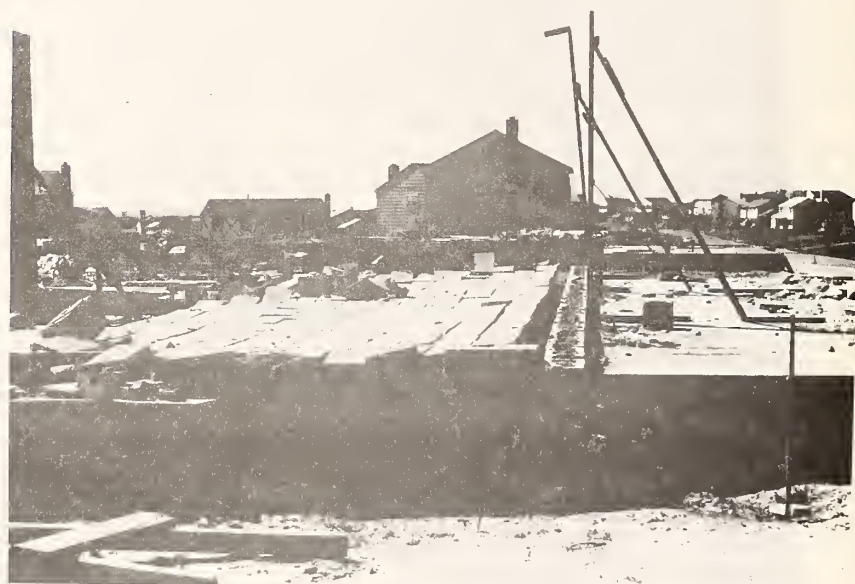
Another instance of masonry wall failure during construction is shown in figures 50 and 51. These walls were braced prior to the storm.

Figure 50 - Masonry wall failure during construction.

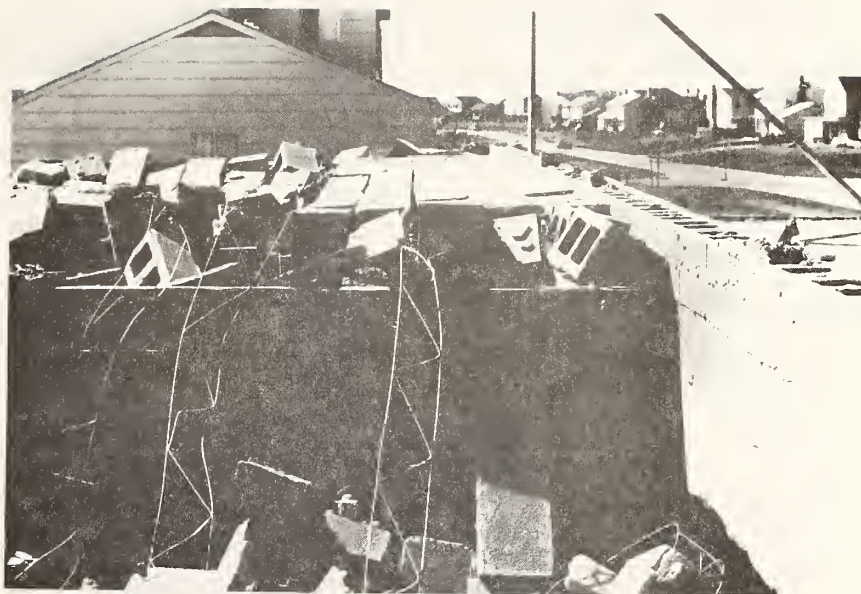
Figure 51 - Closeup view of collapsed wall showing horizontal joint reinforcement.

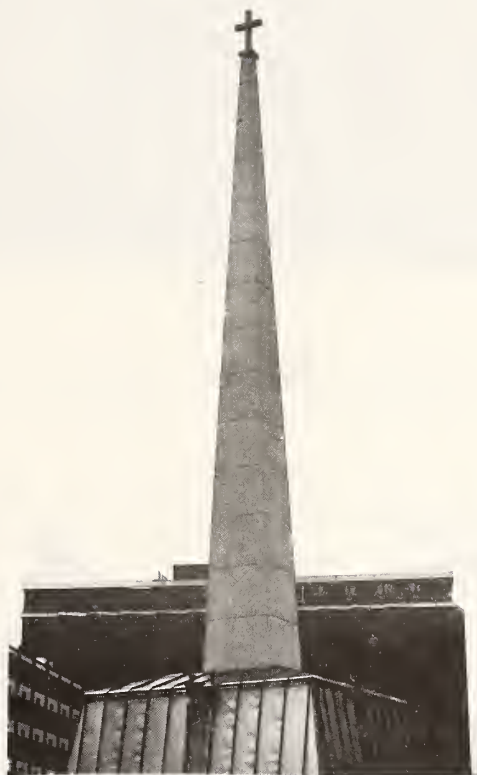
Figure 52 shows an approximately 40 ft (12.2 m) high church steeple which was observed to sway considerably. Figure 53 is a picture of the ceiling at the base of the church steeple. Note the damage that was caused to the cladding by the movement of the steeple. The brittle gypsum ceiling spalled as a result of the movement of the steel truss members.

Figure 52 - Elevation of a church steeple affected by wind.

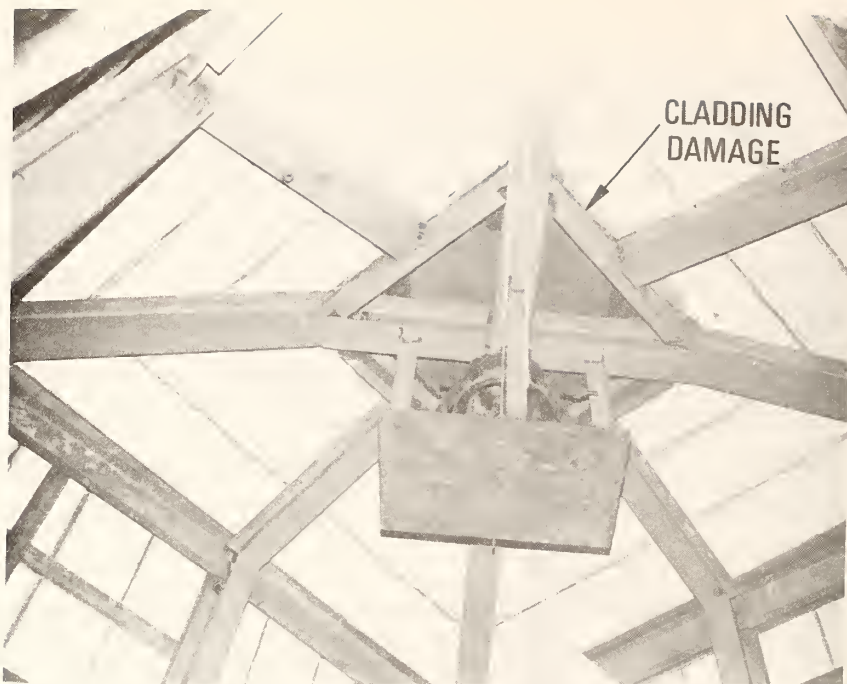
Figure 53 - Damaged ceiling cladding at the base of church steeple.

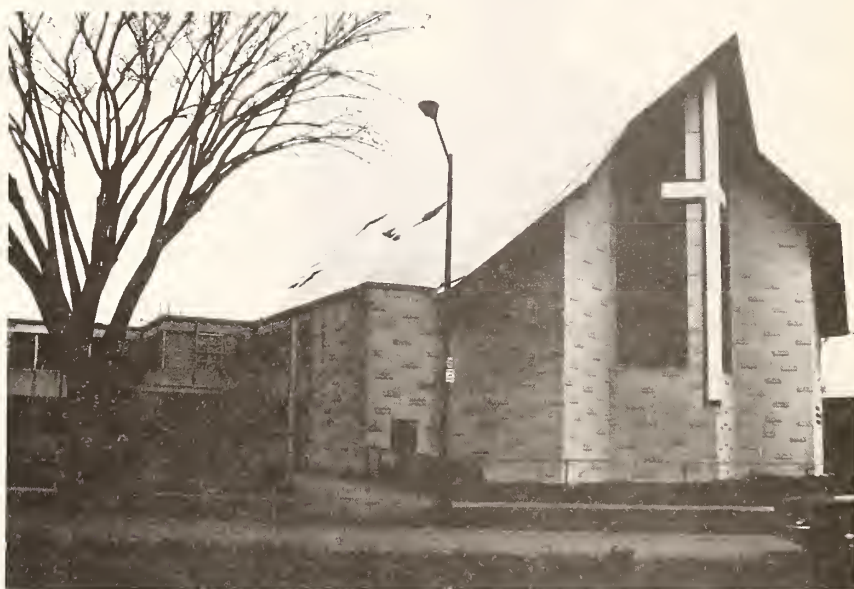
Figure 54 is an overall view of a church which suffered considerable roof damage. Figures 55, 56 and 57 show more detail of the roof damage. Figure 58 shows gaps in the roof which were caused by uplift forces. Damage to the flashing is shown in figure 59. The roofing is rigid asbestos shingles.

Figure 54 - Overall view of a church which suffered roof damage. Looking west.

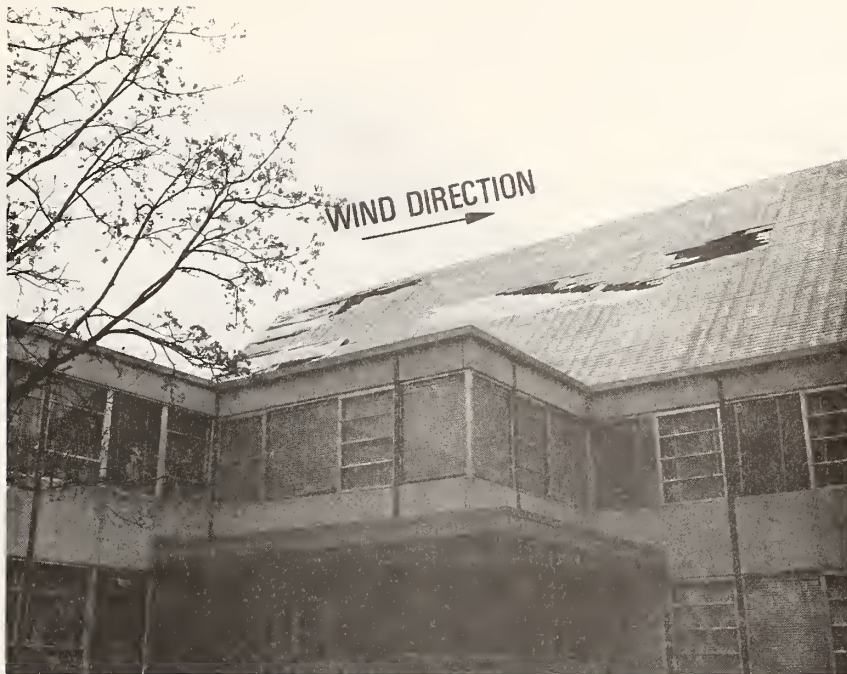
Figure 55 - View along church roof showing extent of roof damage. Looking north.

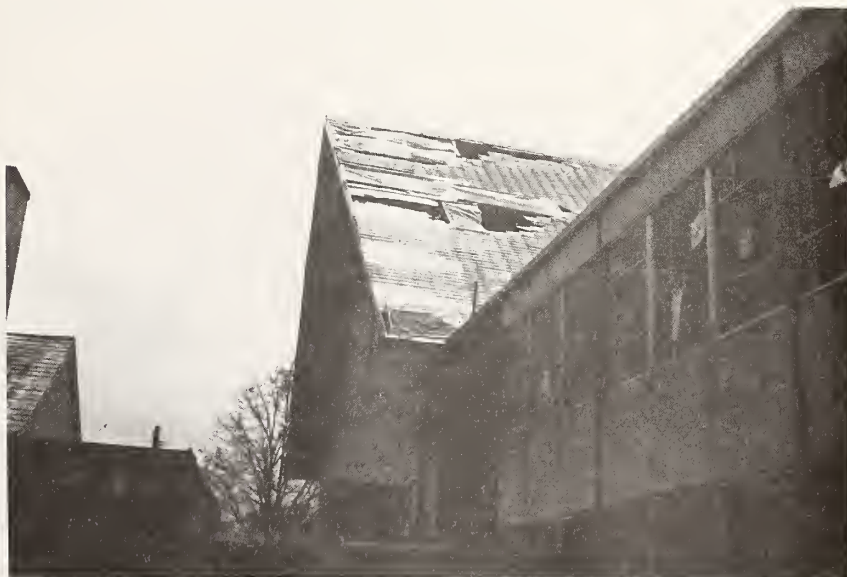
Figure 56 - Roof damage at rear (west side) of church.

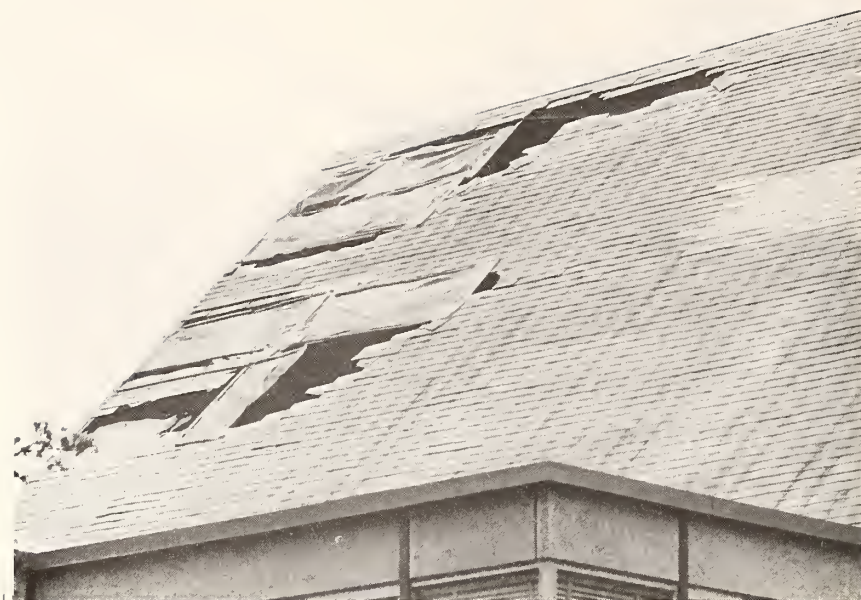
Figure 57 - Closeup view of roof damage at rear of church.

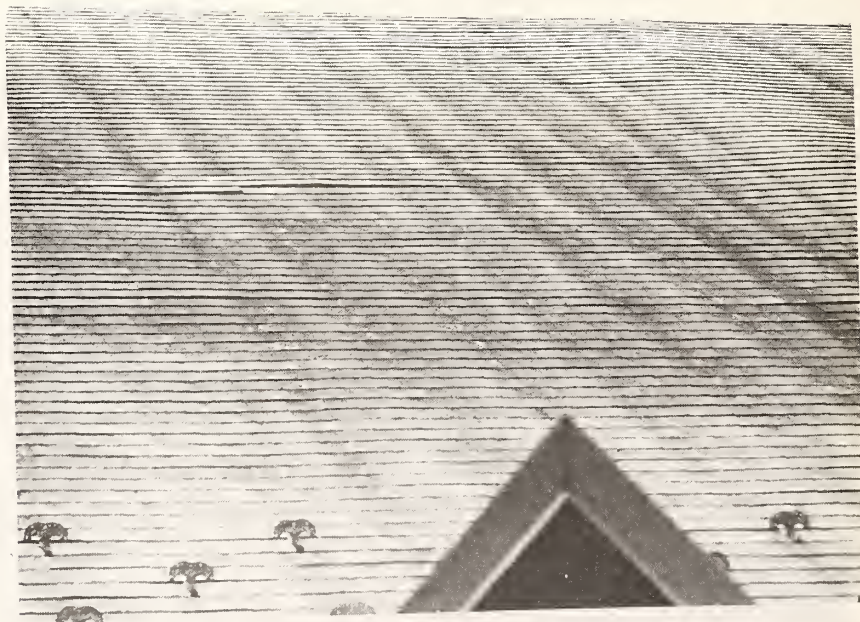
Figure 58 - Uplift of asbestos roof shingles along north side of church.

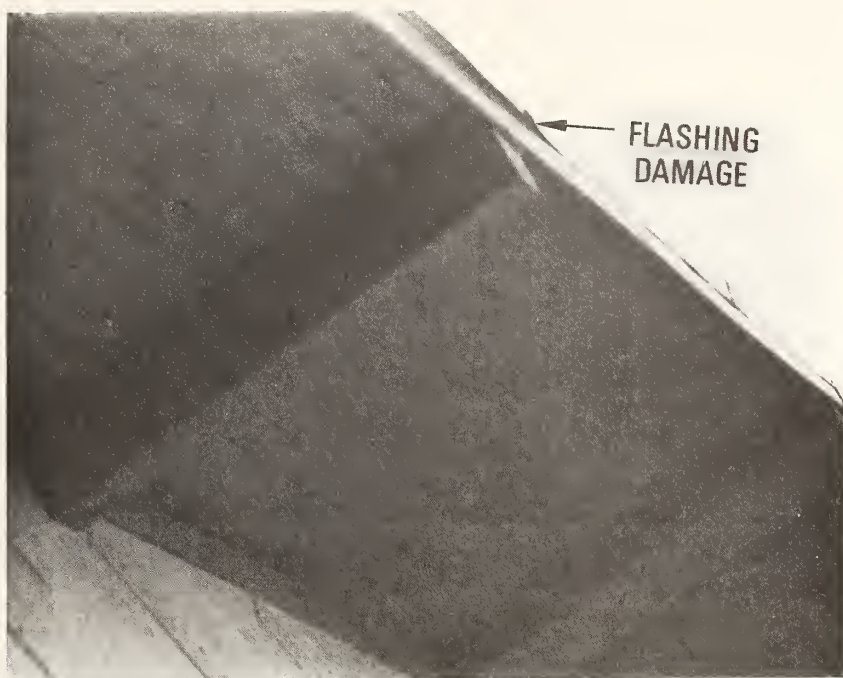
Figure 59 - Damage to roof flashing on gable overhang.

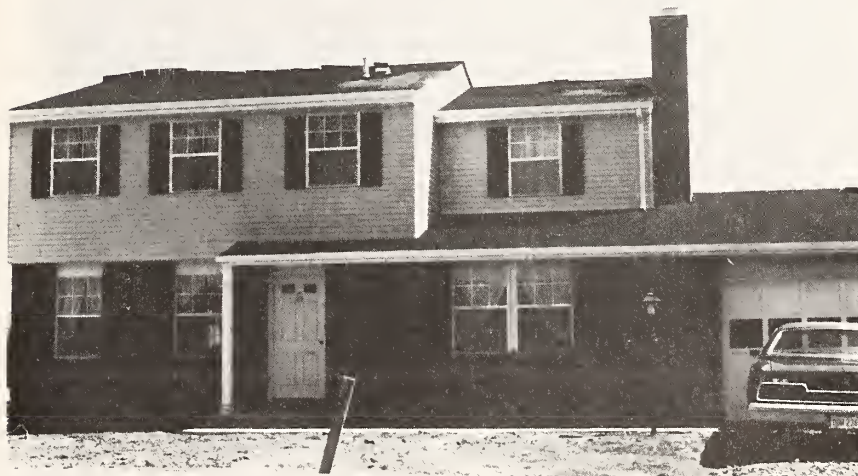
Figure 60 - Damage to asphalt shingle roof located in a new subdivision.

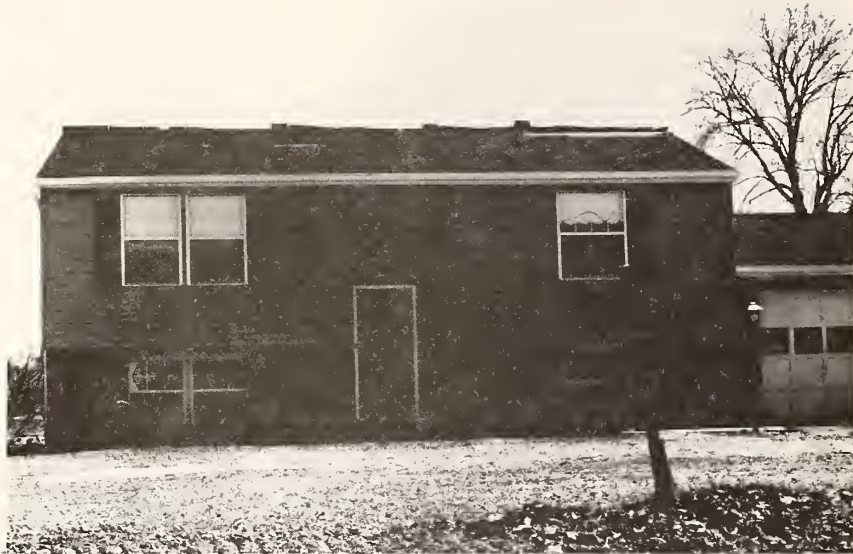
Figure 61 - Uplift of asphalt shingles along ridge and over other roof areas.

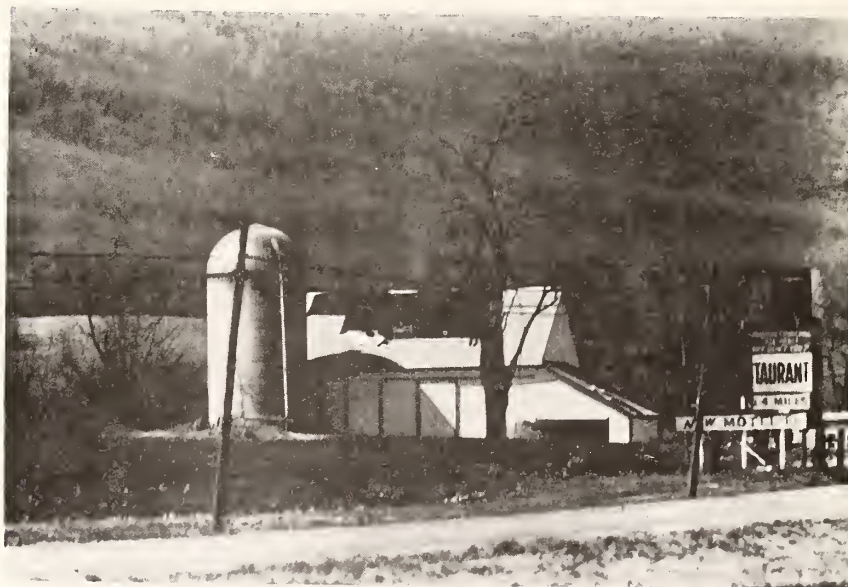
Figure 62 - Roof damage sustained by a barn located in an open area.

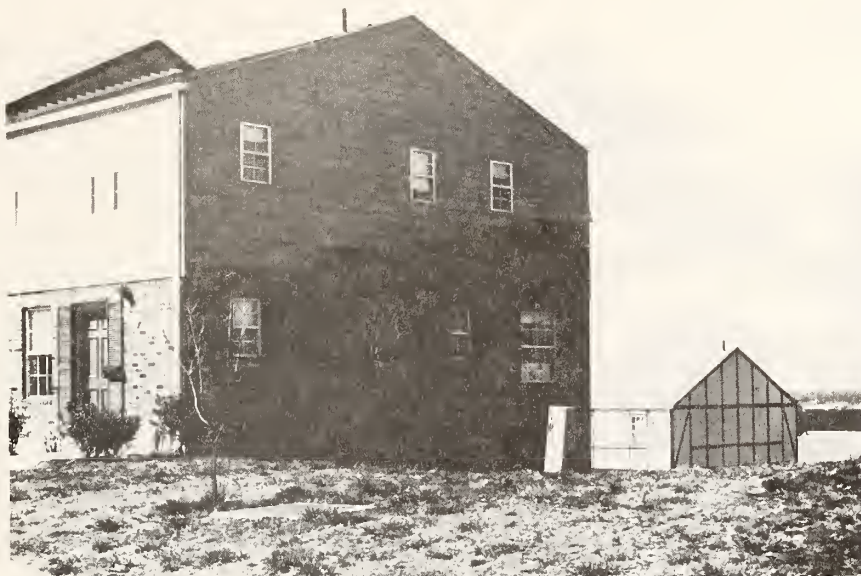
Figure 63 - Damaged sheet metal siding on an end townhouse unit.

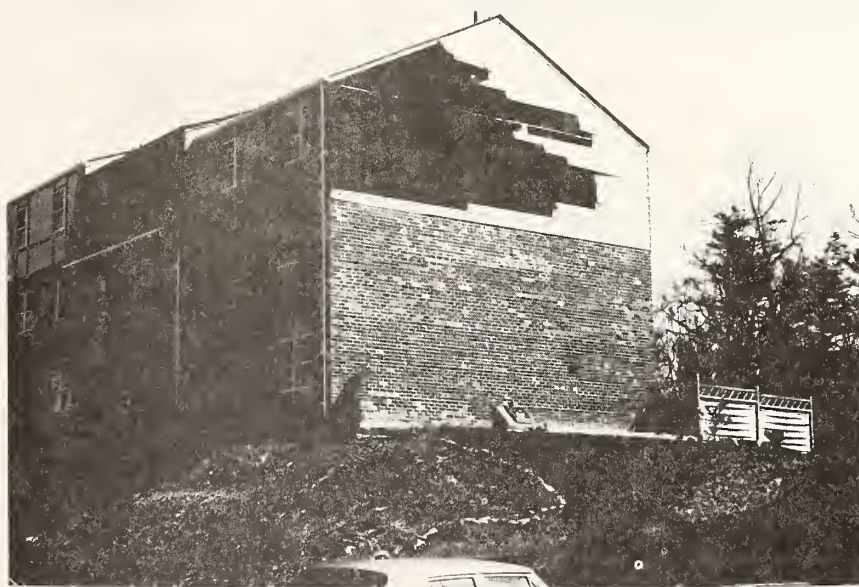
Figure 64 - Damaged sheet metal siding on a townhouse unit.

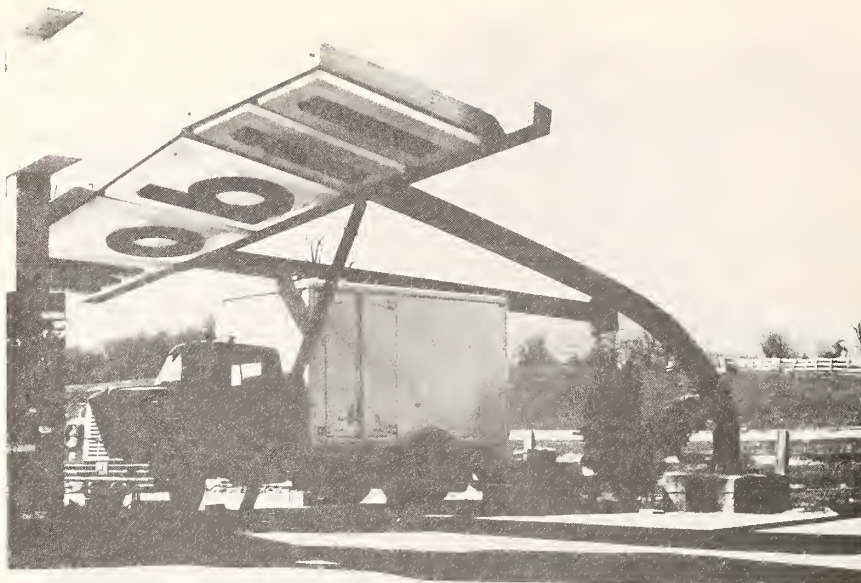
Figure 65 - Overturning failure of a service station sign.

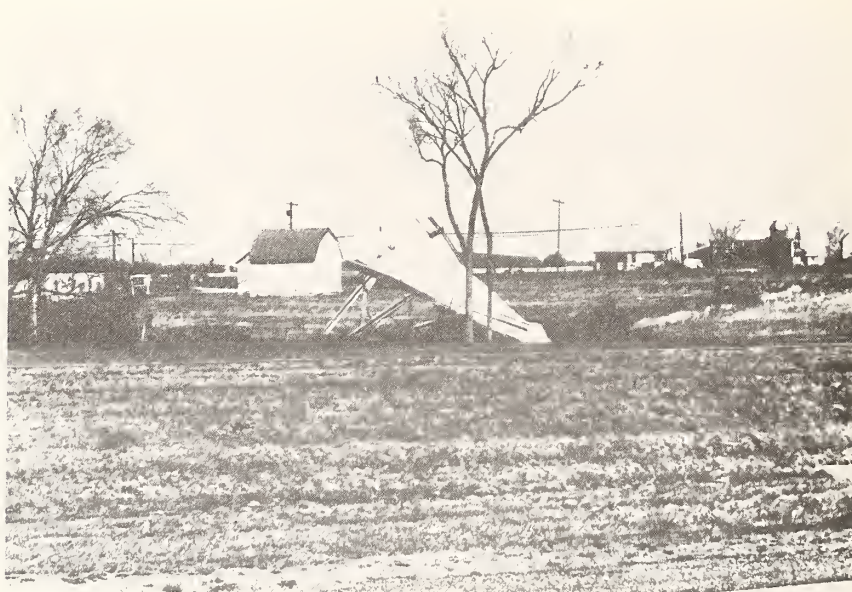
Figure 66 - Overturning failure of a roadside billboard.

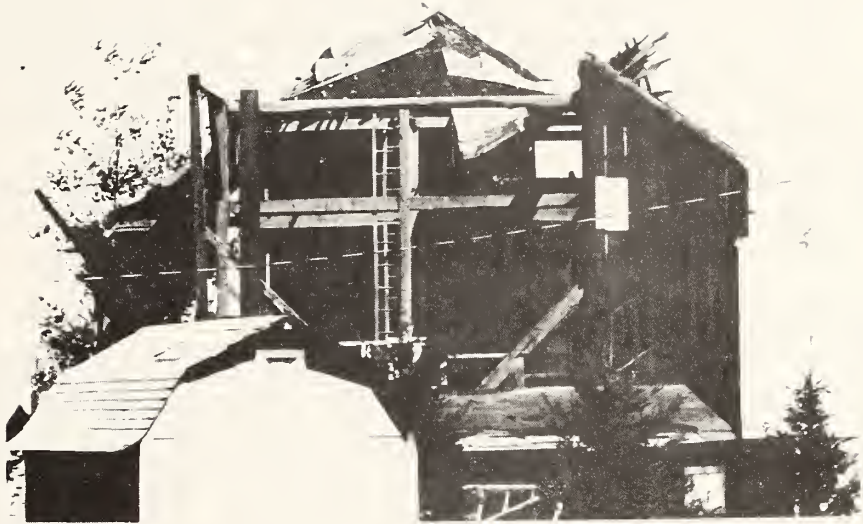
Figure 67 - Partial collapse of a barn located in rural area.
